April 20, 2016  
Project No. 3531-300-01-03b

## LIMITED PHASE II ENVIRONMENTAL SITE ASSESSMENT REPORT

**BROWN'S CHICKEN PROPERTY  
3715, 3721, AND 3725 WEST 147TH STREET  
MIDLOTHIAN, ILLINOIS**

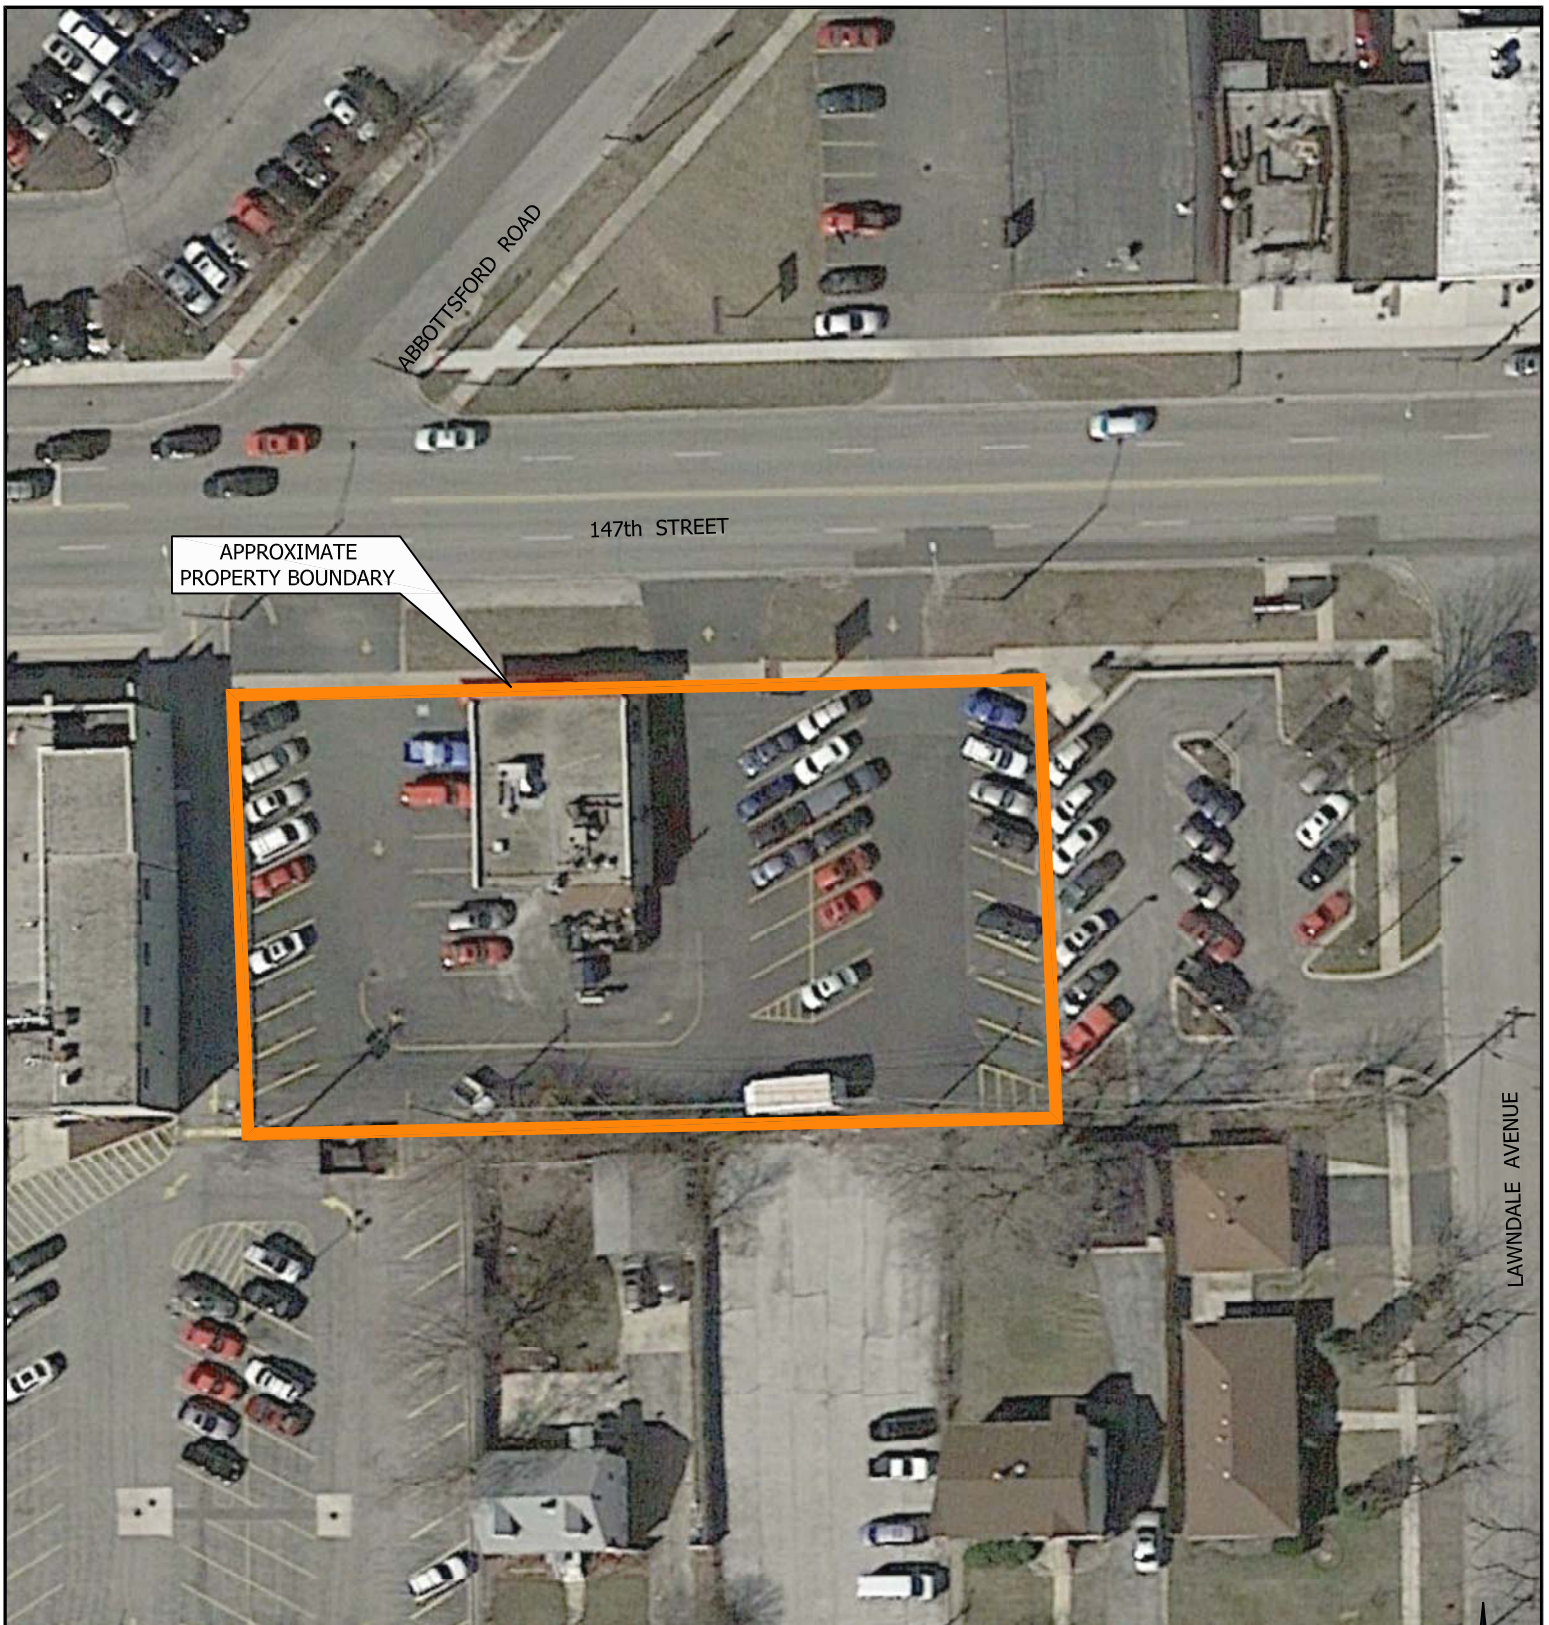
The Property is improved with an approximately 2,000 square-foot, one-story commercial building with a basement. The Property building is currently occupied by Golden Shrimp, a fast food establishment. The Property building is surrounded by an asphalt paved parking lot, with West 147<sup>th</sup> Street adjacent to the north of the Property.
